# A32 VIXXEN / A22LS FOXBAT / KELPIE

## Nose leg inspection recommendations

**Serial number(s) affected:** All serial numbers of A-22LS and A-32 aircraft.

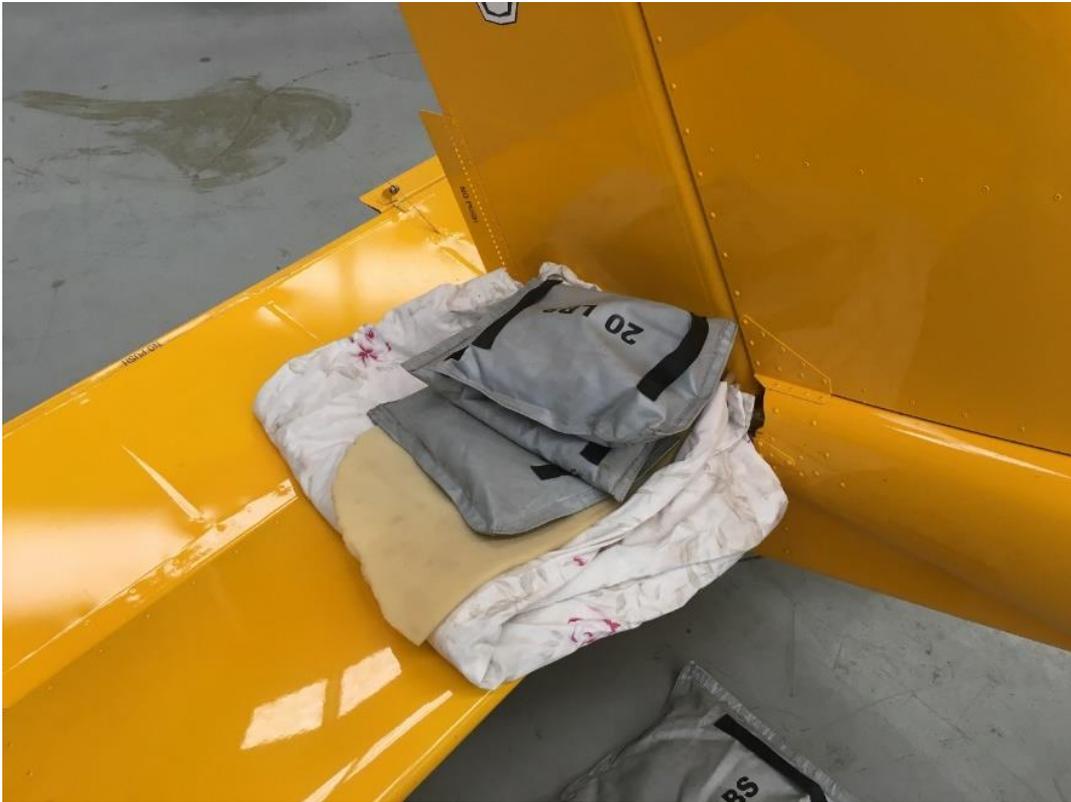
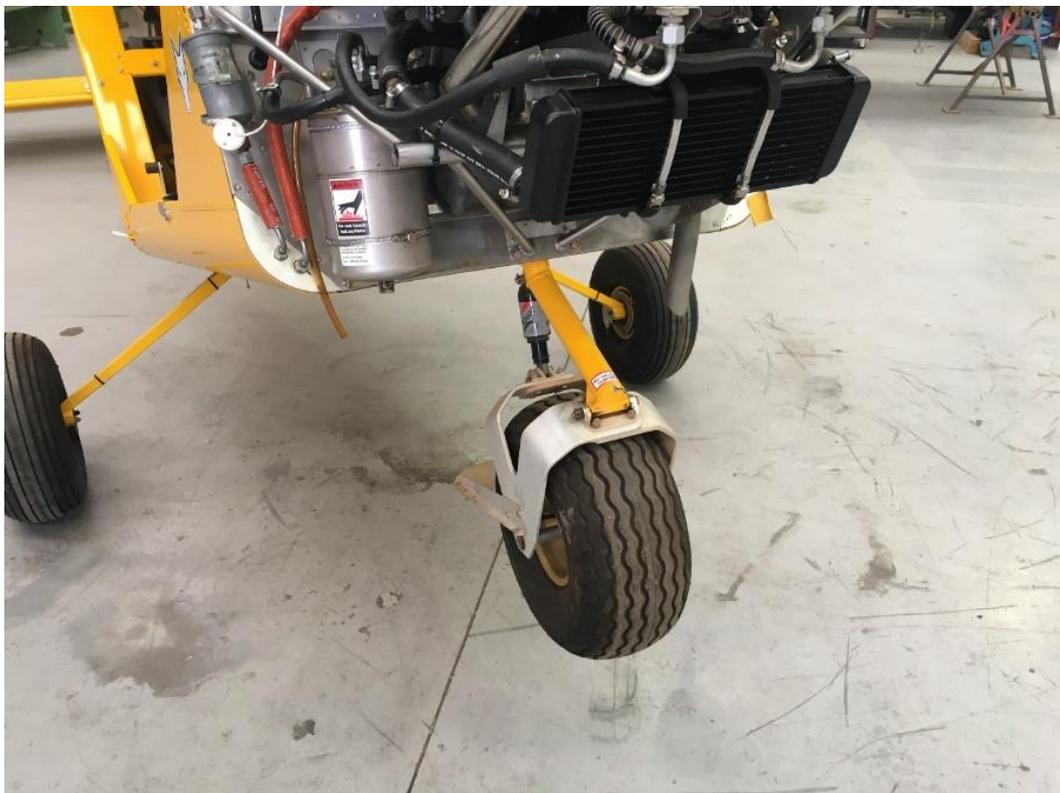
- 1) Lifting of the nose wheel can be done by either a jack at the recommended jacking point or with sand bags on a soft foam located at the root of the stabilizer or AFHT. The aircraft can sit on the tail wheel or rear skit in this attitude.

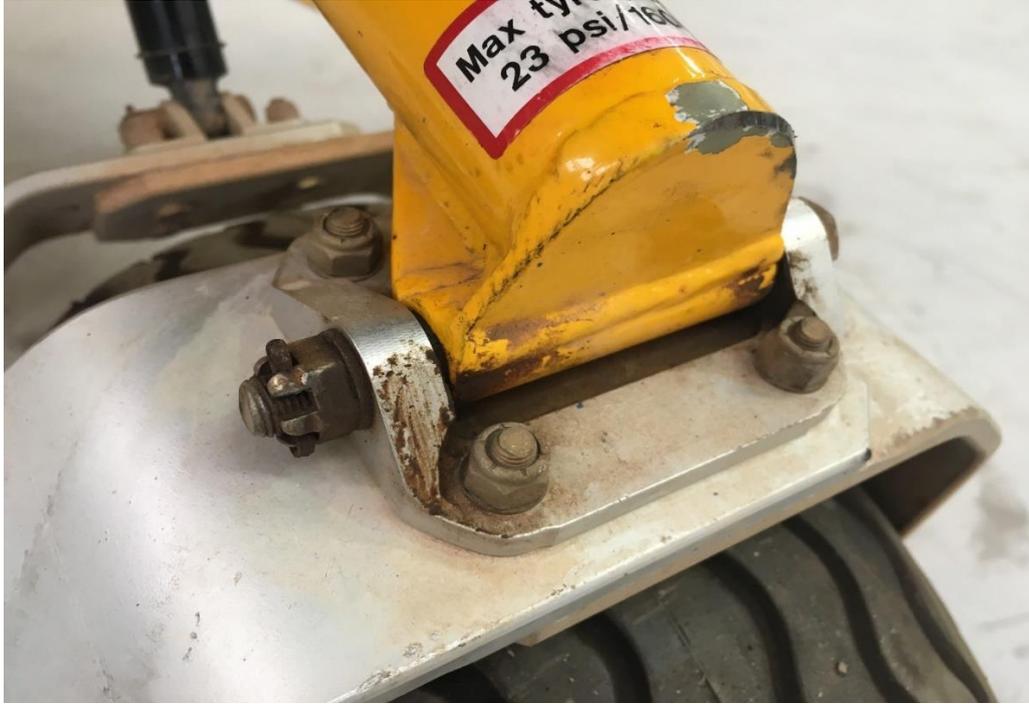
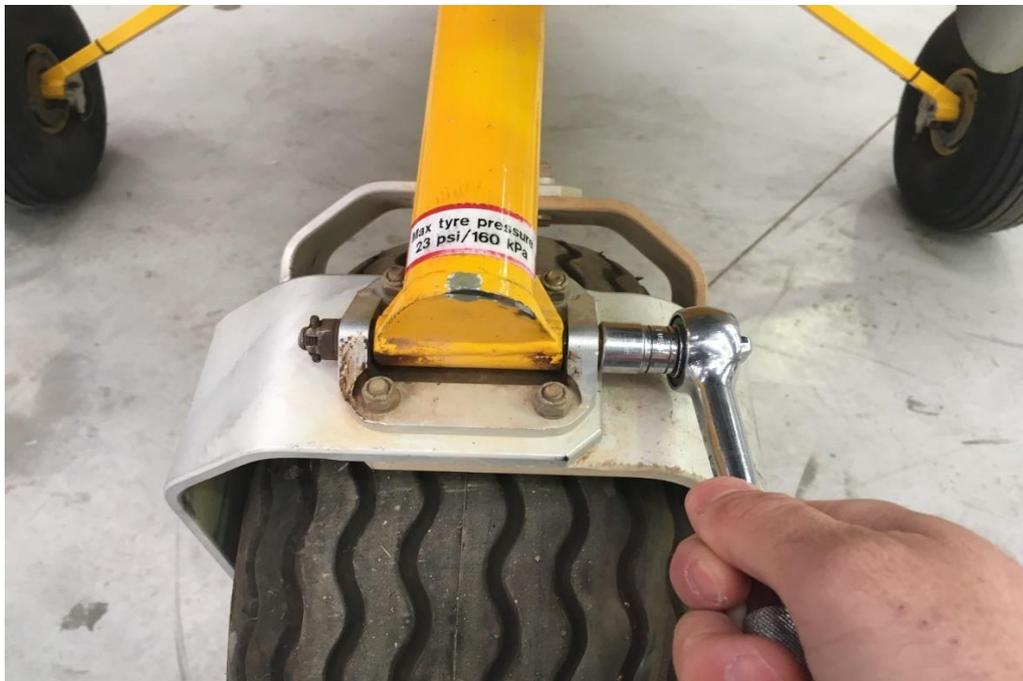
- 2) Make sure that the bolt is not seized by applying light pressure using the appropriate size spanner first, before removing it. If the bolt was seized, it is likely that large forces were exerted on the lower attachment bracket and therefore, must be inspected thoroughly for cracks and over stress damage.

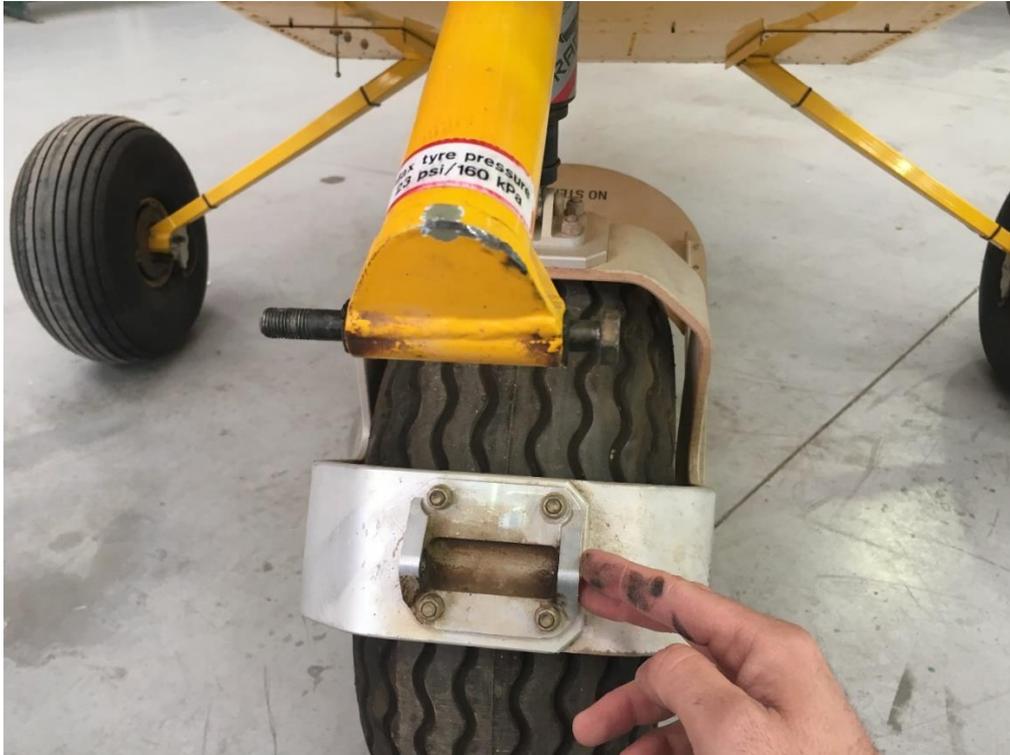
- 3) Remove the split pin, nut and bolt and carefully lower the leg and wheel to the rear.

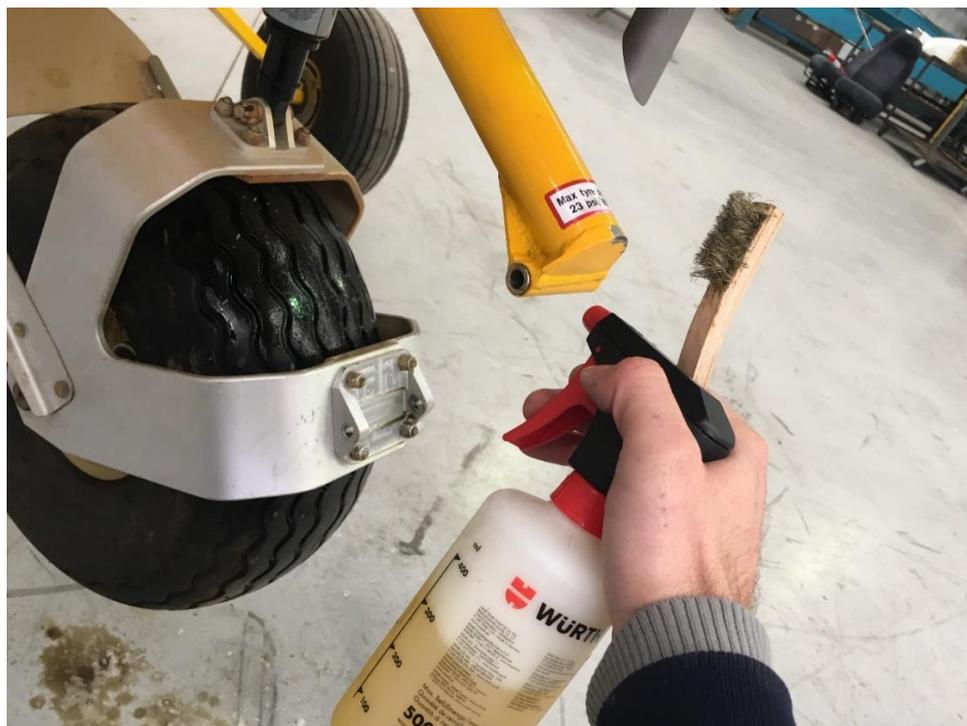
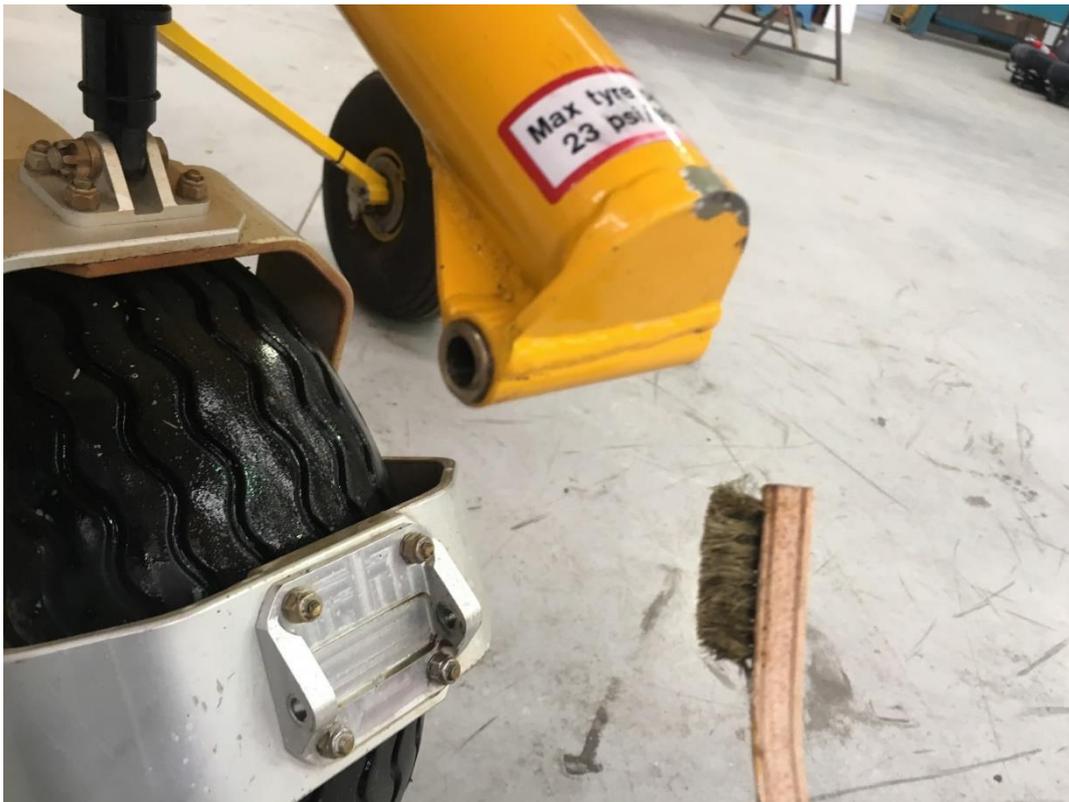
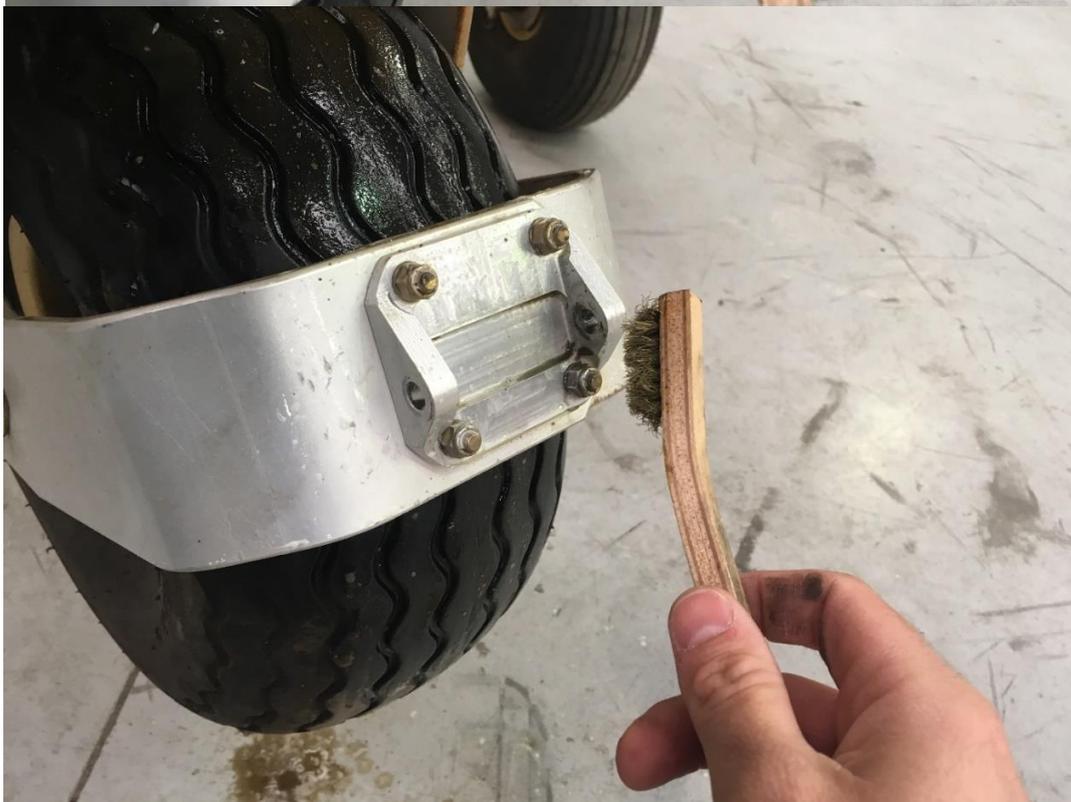
- 4) Clean the area using anti corrosive products and use a soft tool to agitate all dust and remove older grease deposit off the bracket and bolt, be careful not to damage the bronze bushes on either side of the nose leg.

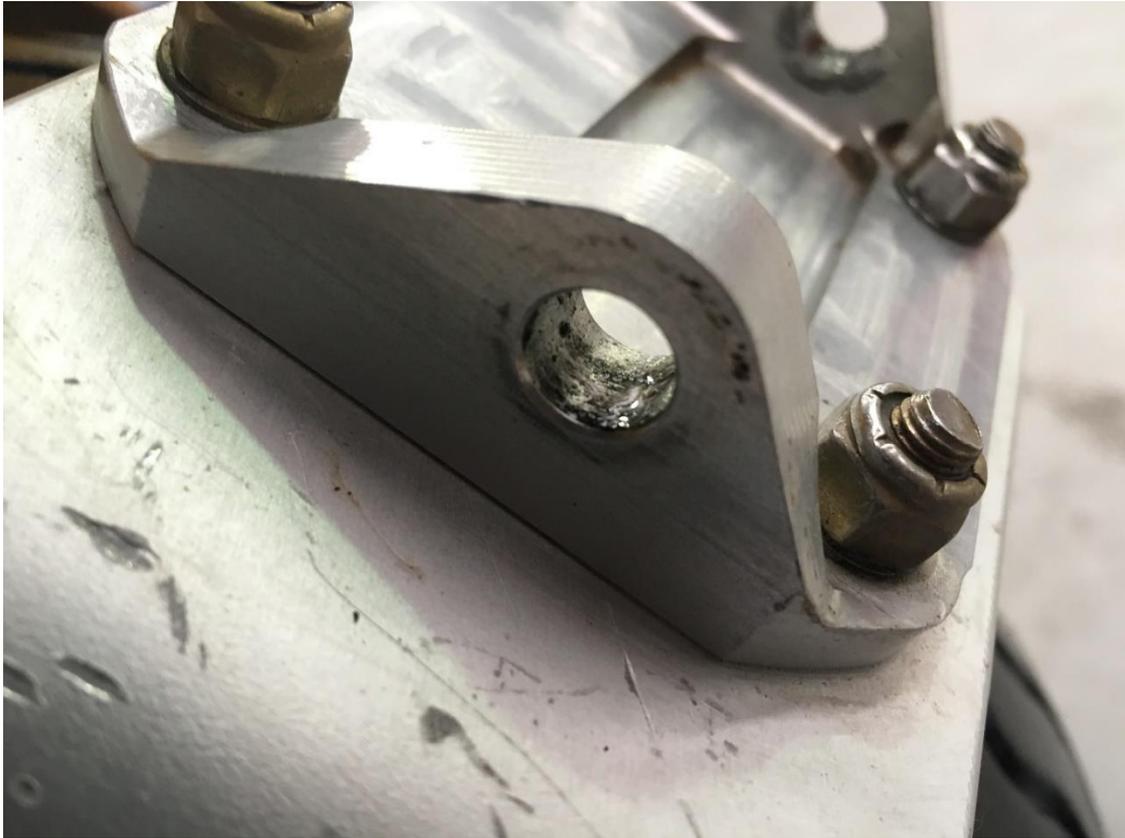
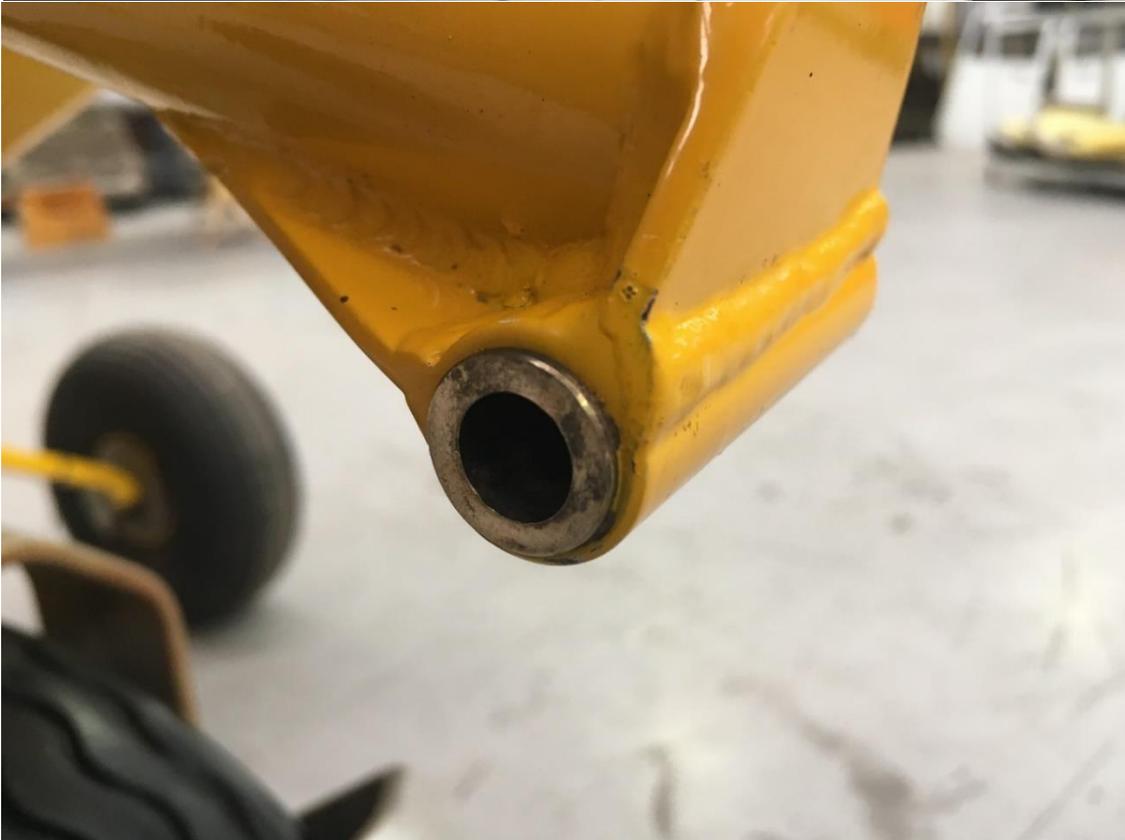
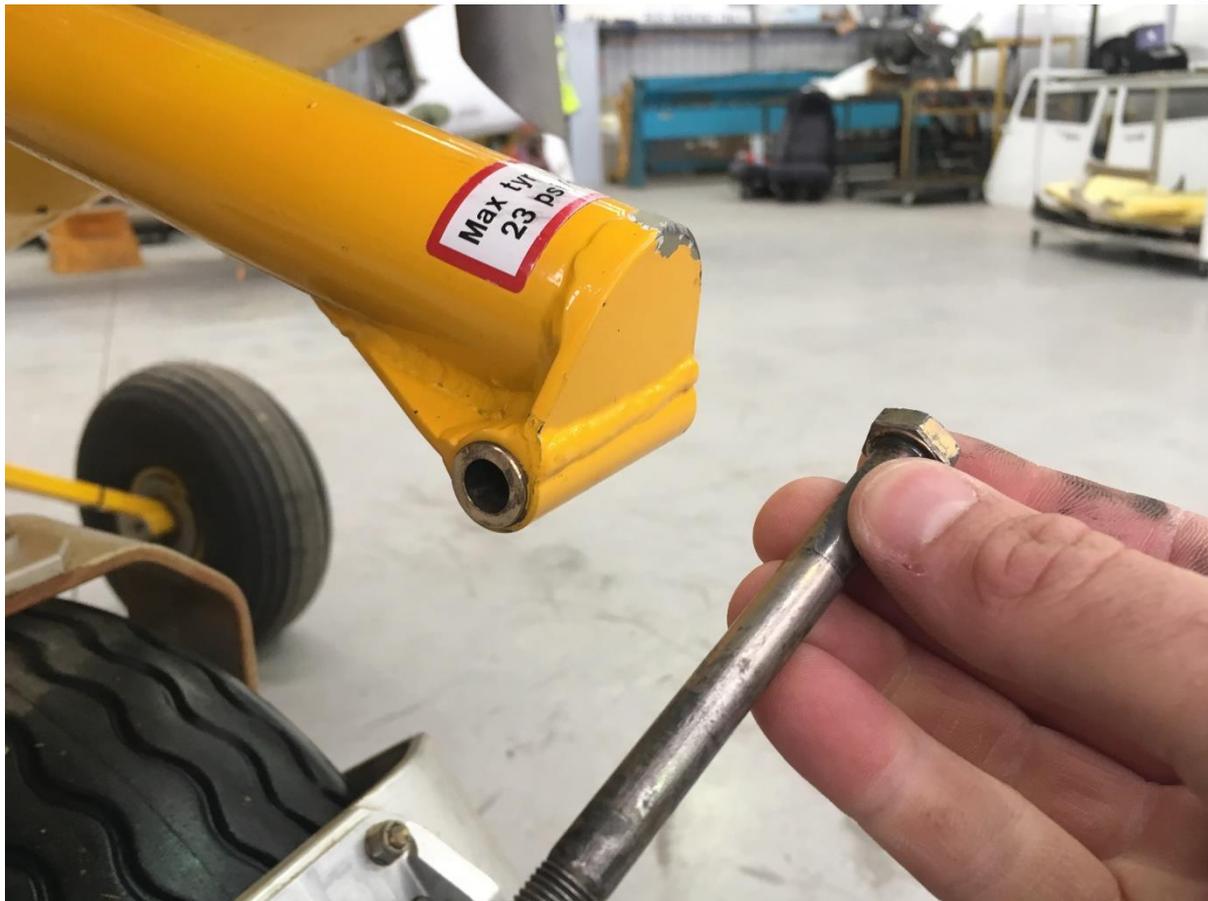
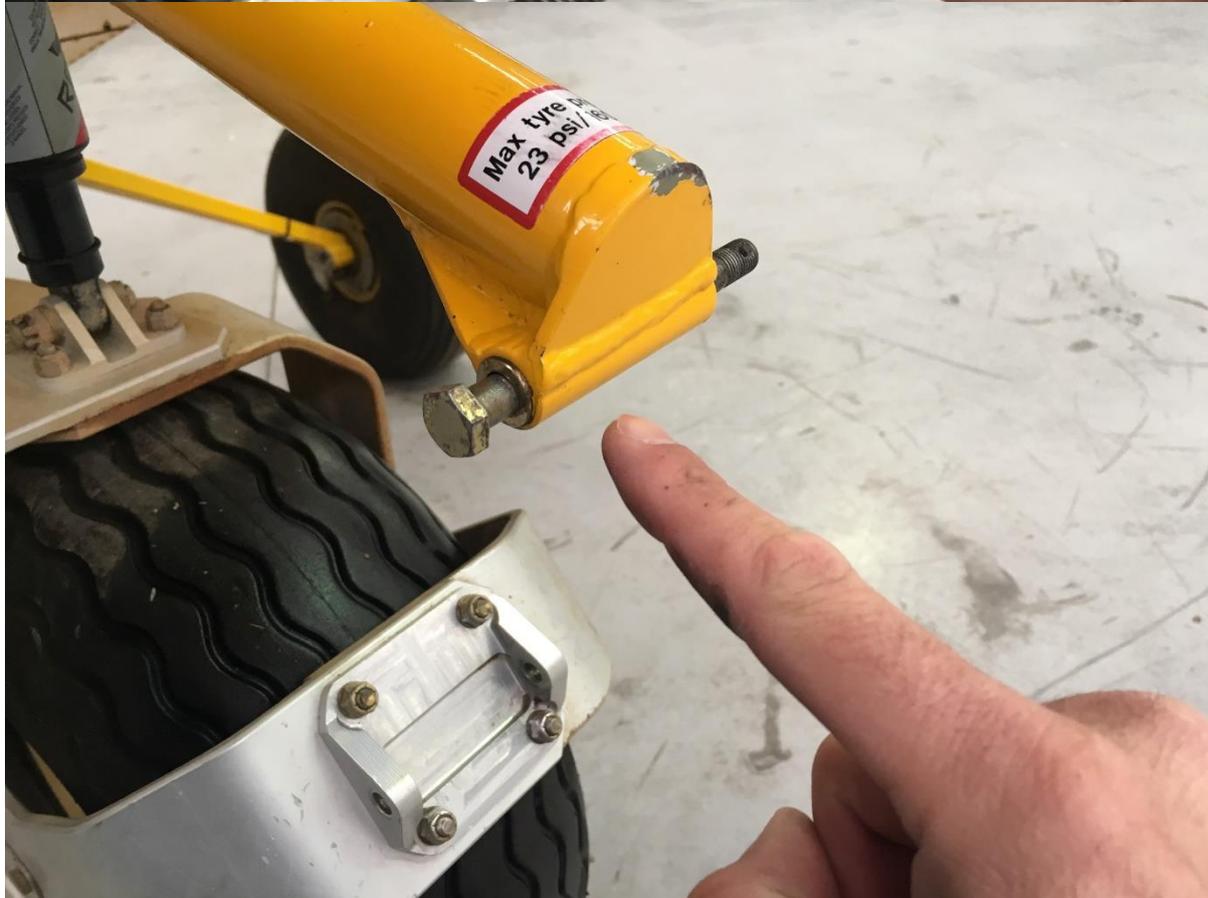
- 5) Once the parts are cleaned, perform a detailed inspection on the bracket and all attachment points, as well as the nose leg itself.

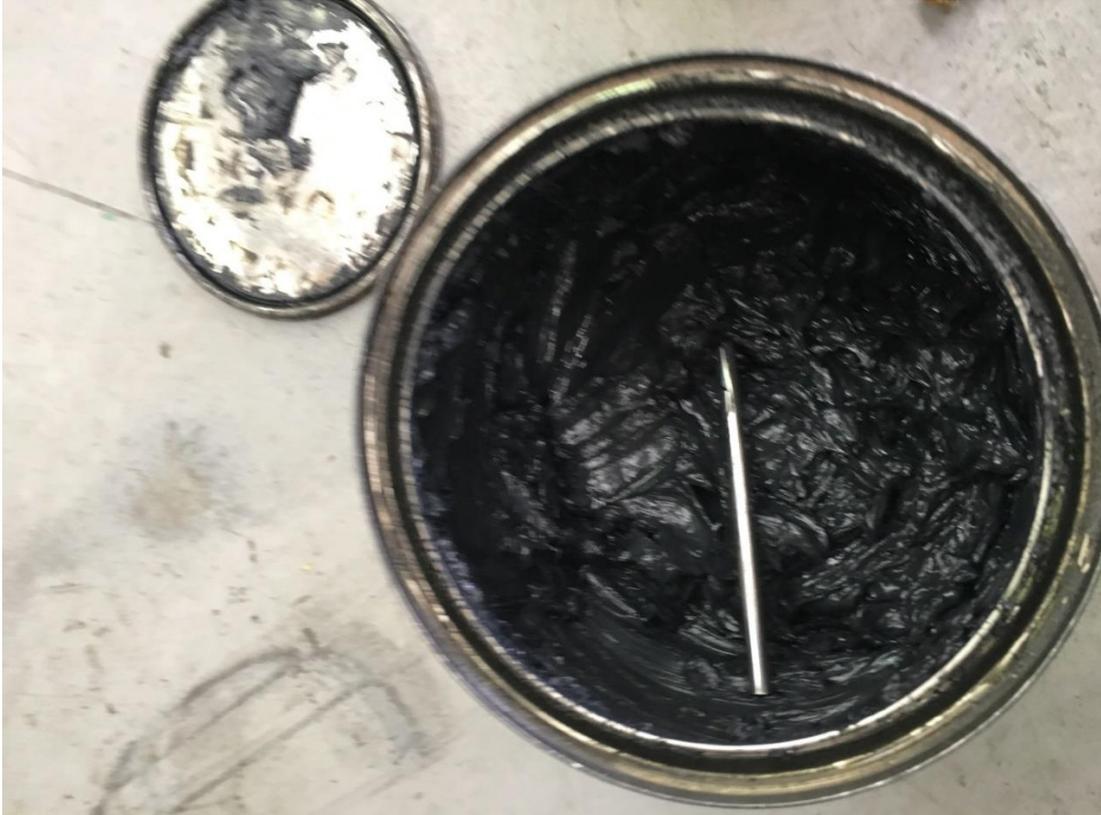
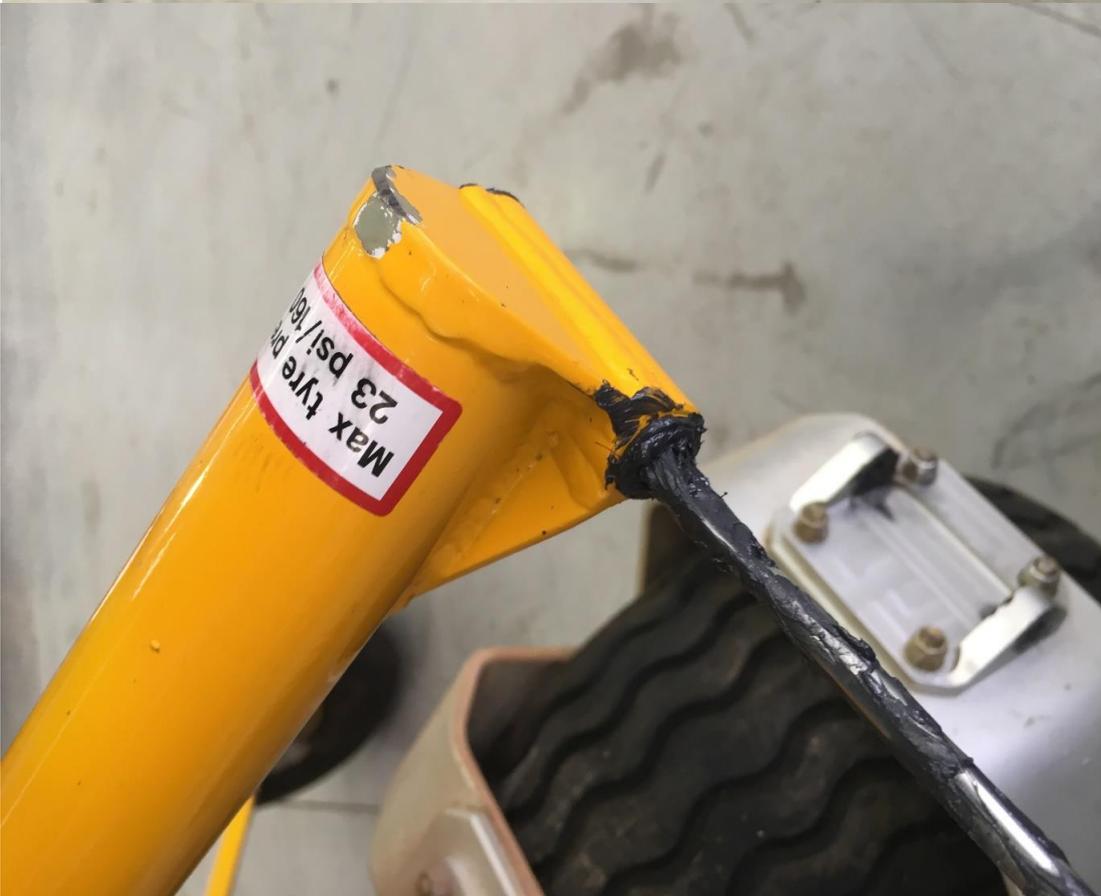
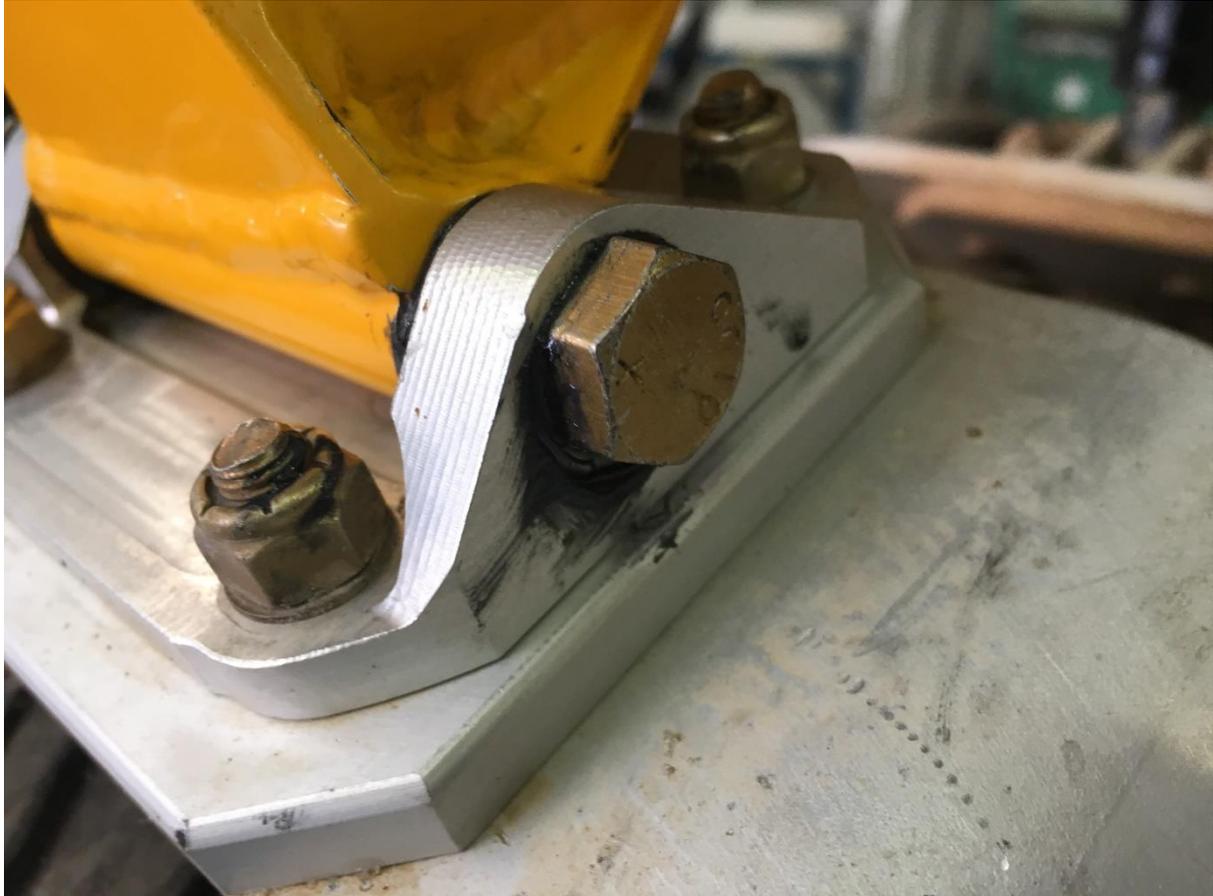
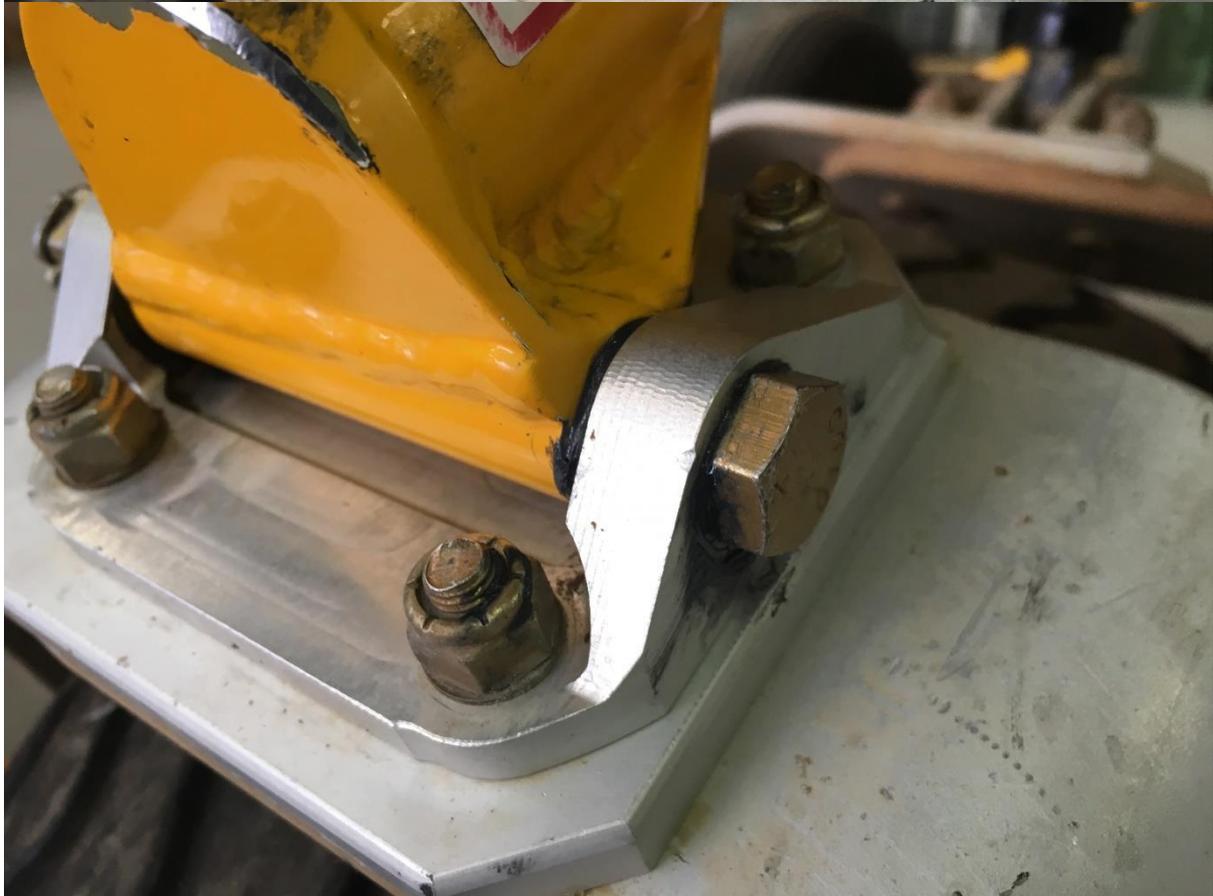
6) Before re-installation, use heavy grease with anti-moisture, anti-corrosion elements and insert inside the leg, apply on bolt and in all areas of movement.
